CHADWICK LAKE DAM

PHASE I INSPECTION REPORT

Name of Dam: Chadwick Lake Dam
County and State: Orange County, State of New York
Inventory Number: NY 509

Prepared by: O'Brien and Gere Engineers, Inc.

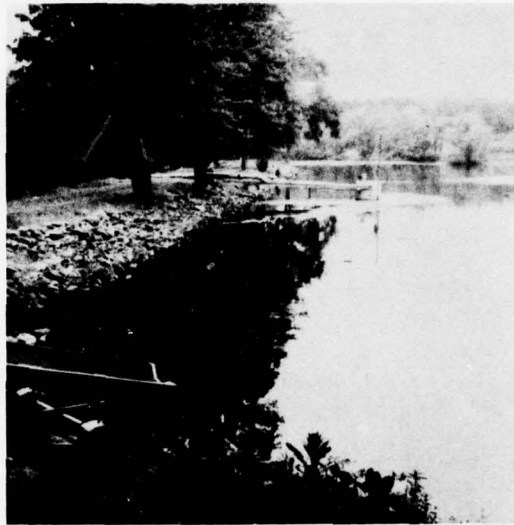
UPSTREAM VIEW OF DAM

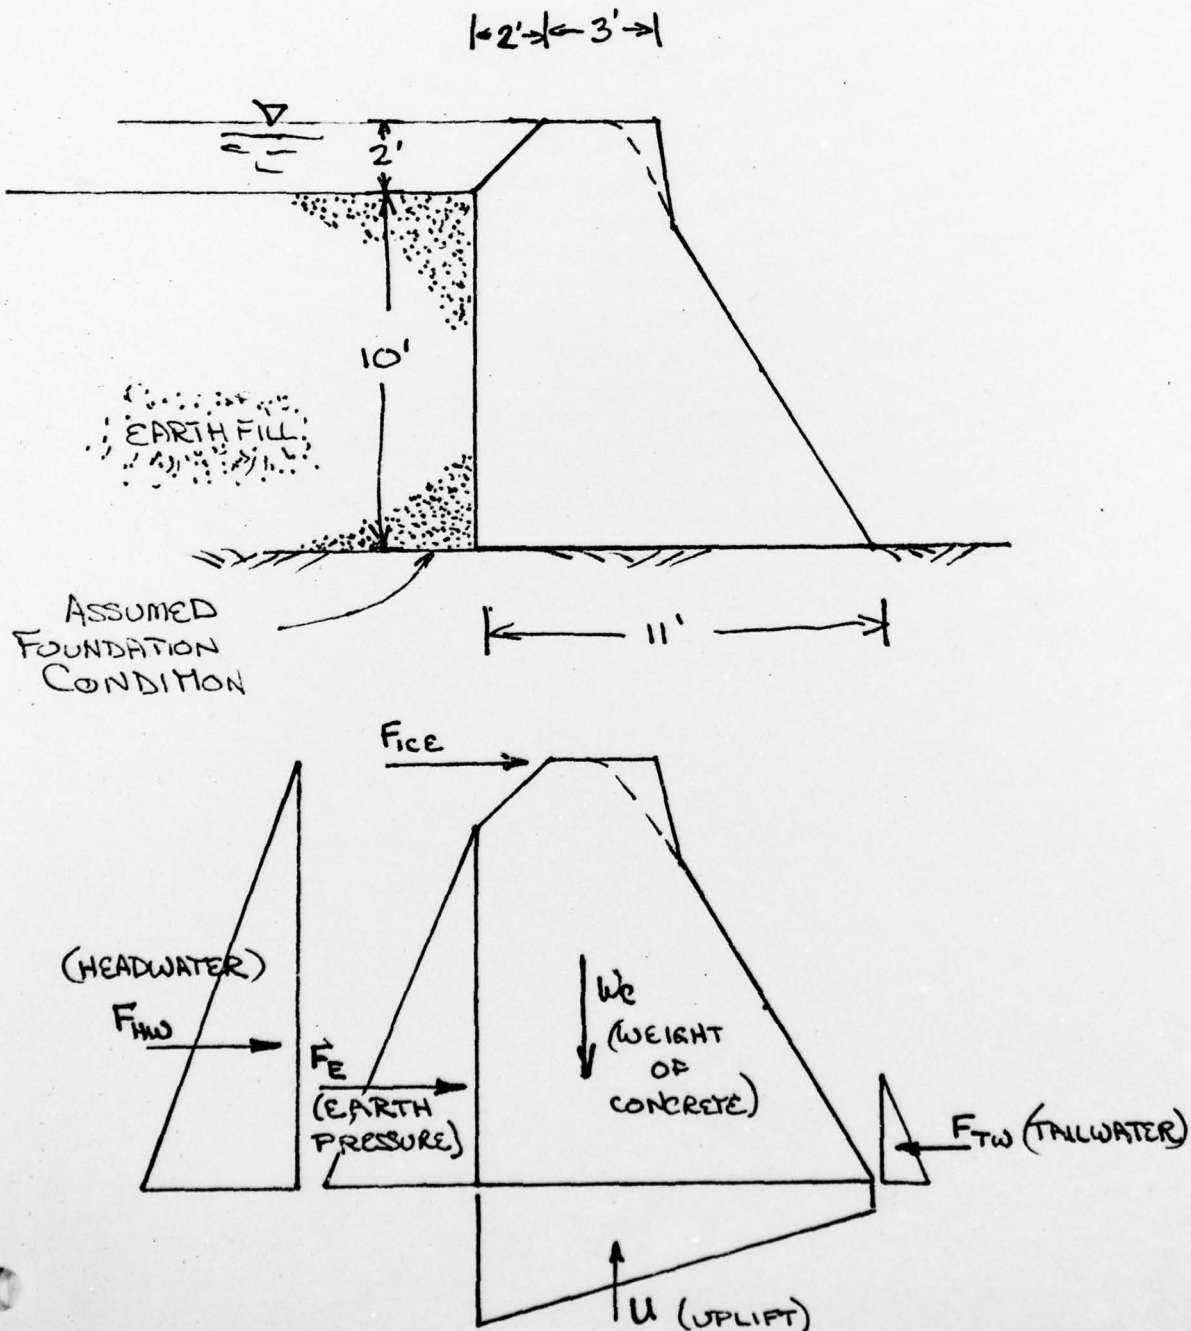
SPILLWAY STABILITY ANALYSIS

This stability analysis (see Appendix) indicates the spillway structure to be stable for normal pool and earthquake loadings. Tension was found to develop in the heel of the spillway for the condition of headwater at the top of embankment. For the ice loading condition, overturning instability is indicated.

NET HORIZONTAL FORCE= 8.29 KIPS
 NET VERTICAL FORCE= 8.53 KIPS
 NET MOMENT= 20.28KIP-Feet
 X-BAR OF FOUNDATION REACTION= 2.38 FEET
 ECCENTRICITY OF FOUNDATION REACTION FROM CENTER= 3.12 FEET
 *****FOUNDATION REACTION NOT IN CENTRAL THIRD OF BASE*****TENSION AT HEEL OF DAM*****
 FOUNDATION REACTION PRESSURES*****TOE= 14.55 PSI*****HEEL= -3.78 PSI*****
 OVERTURNING FACTOR OF SAFETY= 1.28
 SLIDING FACTOR OF SAFETY= .62
 DEVELOPED FRICTION FACTOR (NO SHEAR)= .97
 SLIDING WITH SHEAR FACTOR OF SAFETY= 10.17(SHEAR ACROSS FULL DASE WIDTH)

NET HORIZONTAL FORCE= 11.07 KIPS
NET VERTICAL FORCE= 11.14 KIPS
NET MOMENT= -3.09 KIP-Feet
X-BAR OF FOUNDATION REACTION= -28 FEET
ECCENTRICITY OF FOUNDATION REACTION FROM CENTER= 5.74 FEET
*****FOUNDATION REACTION NOT IN CENTRAL THIRD OF BASE*****TENSION AT HEEL OF DAM*****
FOUNDATION REACTION PRESSURES*****TOE= 29.18 PSI*****HEEL= -15.12 PSI*****
OVERTURNING FACTOR OF SAFETY= .97
SLIDING FACTOR OF SAFETY= .60
DEVELOPED FRICTION FACTOR (NO SHEAR)= .99
SLIDING WITH SHEAR FACTOR OF SAFETY= 7.75(SHEAR ACROSS FULL BASE WIDTH)

3) The spillway should be strengthened to provide adequate factors of safety for all loading conditions. The downstream face of the spillway structure should be given a concrete coating to seal and repair the surface. This coating should also be placed so as to seal the base of the structure to the underlying rock and prevent further undermining.
